THESIS FOR THE DEGREE OF DOCTOR OF PHILOSOPHY

Damage and defects in railway materials:

Influence of mechanical and thermal damage on crack initiation and propagation

Department of Industrial and Materials Science

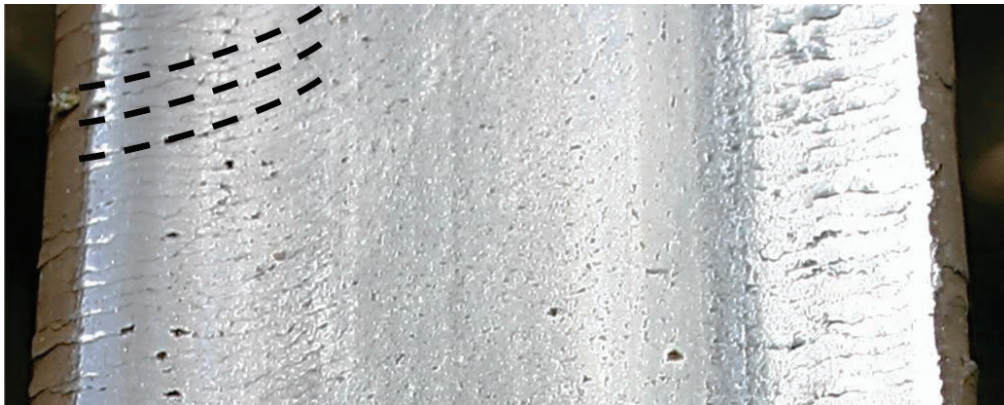
Figure 2. Commonly occurring RCF defects on the gauge corner of rails. Dashed lines highlight the curvature of the head checks from the gauge corner into the running band. [27]

Rolling contact fatigue (RCF) is defined as the fatigue of materials in contact in conjunction with rolling contact and normal loads. A commonly occurring form of RCF cracking is head checks (Figure 2). These are recurring cracks on the gauge corner of rails, but are benign and usually removed by regular rail grinding and maintenance [20]–[22]. However, if not properly maintained, gauge corner cracking (GCC) can lead to the formation of squat cracks. In recent years, the occurrence of this type of surface-initiated defect has been more present and studied. These squats and squat type defects can be a problem due to their location in the rail. Depending on the loading scenario and the orientation of the crack tip, they can either plateau parallel to the surface, or they can turn downwards and cause complete rail fracture.

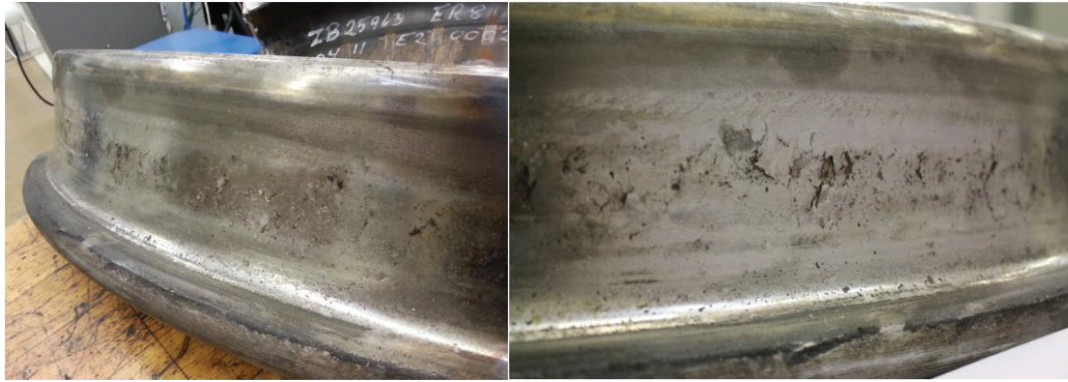
Figure 31. Wheel treads with RCF1 and RCF3 damage bands.

Macro photographs from visual inspection show RCF1 and RCF3 damage bands spread around the entire circumference (Figure 31). After the first overall examination, the surfaces of the wheels were etched using Nital, but no clear signs of martensite patches became apparent. This, in combination with the continuous damage, speaks against thermal initiation of the cracks, e.g. at small wheel flats or more serious skid patches. It should be noted that this does not imply that thermal loading had no influence on the damage formation, since it has been shown that even moderate thermal loads may have a detrimental influence on the wheel material [71]. However, no high temperature events, i.e. large-scale sliding of the wheel on the rail, have been involved in the formation of damage.
